***Arlington School Committee  
School Committee Special Meeting  
Monday, April 7, 2025  
5:45 PM***

# Ottoson Middle School: Property Overview

Statement of Interest 2025

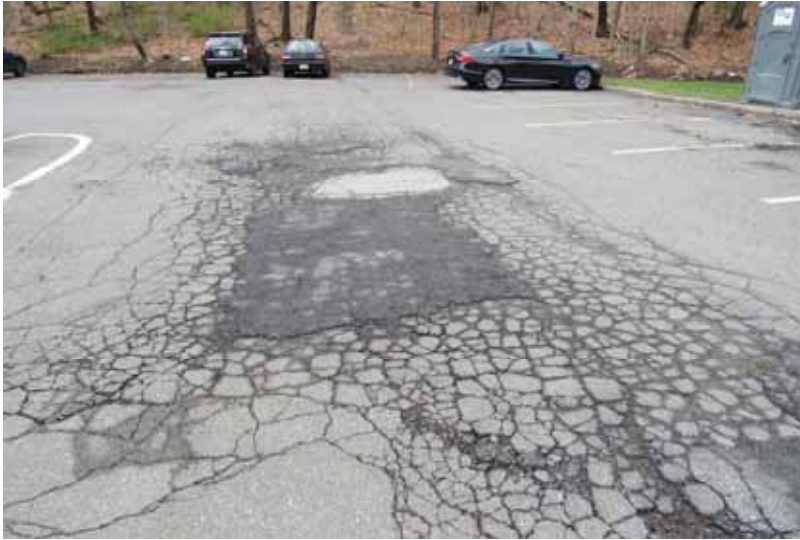
View of widespread pattern cracking and evidence of fatigue within asphalt-paved surface parking area as seen at rear of development

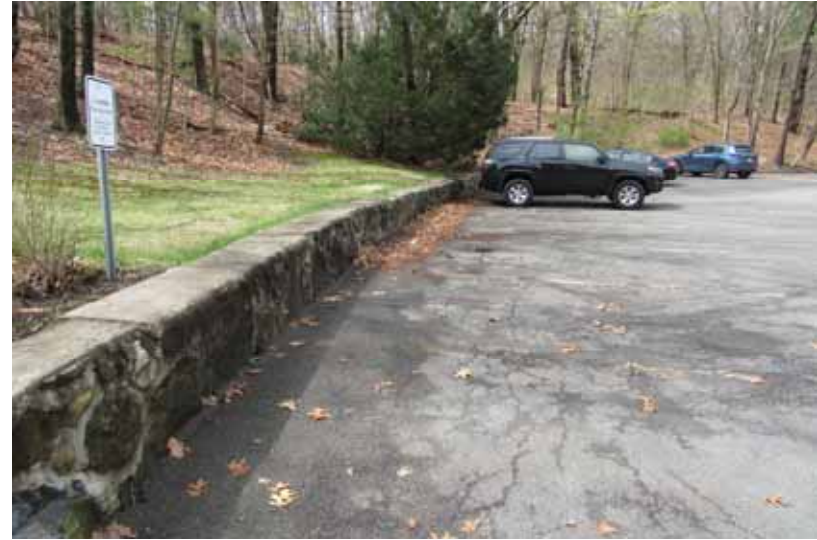
Additional view of pattern cracking and evidence of fatigue within asphalt pavement

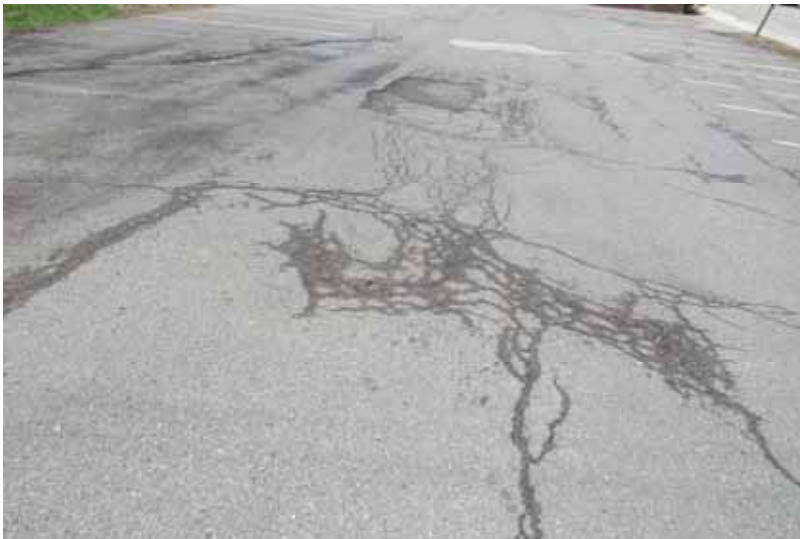
View of northeast corner lower asphalt parking lot – note similar deterioration/age related wear

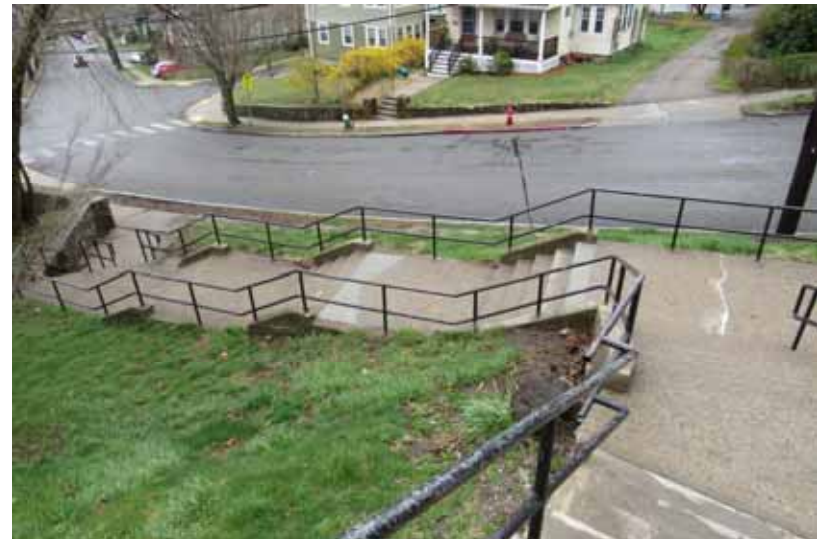
3. The concrete walkways, site steps, and landings vary in condition. Management reports concrete step replacement was carried out in recent years. Localized cracking and concrete spalls were observed within the steps, landings, and walkways. Periodic costs to carry out sectional concrete repairs/replacement (including as-needed refurbishment of metal railings/guardrails) are shown every eight years starting in Year 1.

View of east end concrete site steps and metal railings – railings exhibit paint peeling/weathering

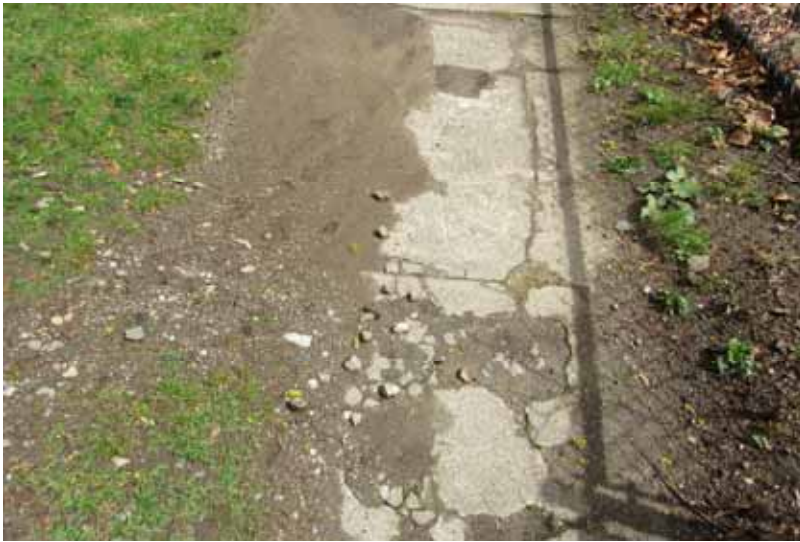
View of concrete deterioration within walkway  
as seen towards southeast corner of building

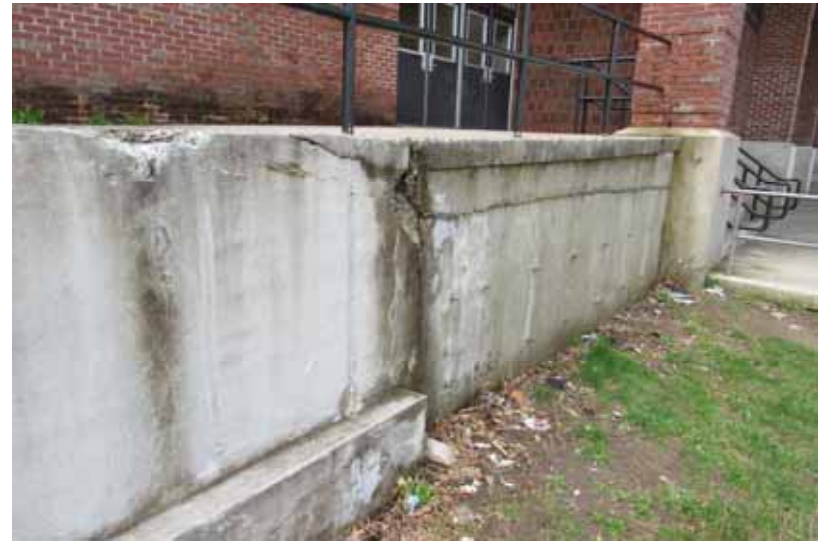
View of cast-in-place concrete retaining wall present towards  
northeast corner of building – note concrete spalls/deterioration

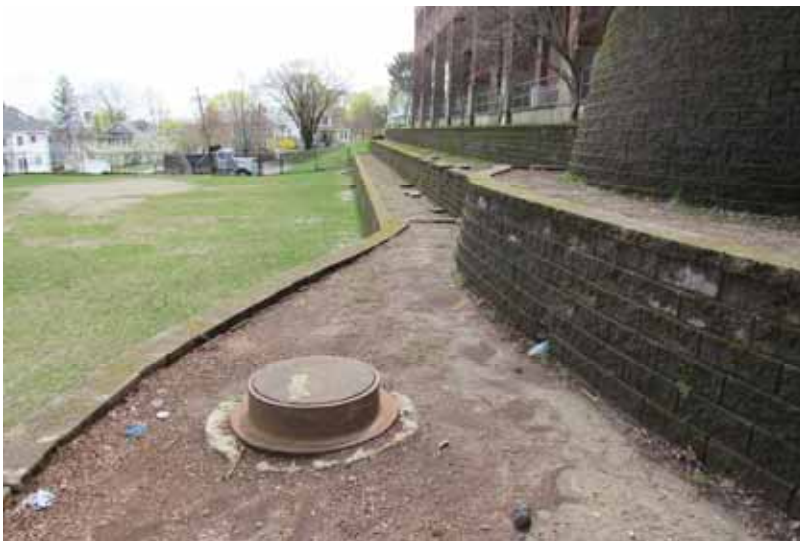
4. Several displaced concrete block masonry units were observed within the front elevation retaining walls. Furthermore, localized mortar loss/deterioration was noted within the development's perimeter stone retaining walls. Periodic costs to carry out as-needed retaining wall repairs/replacement are shown every five years starting in Year 1. These costs also include pressure washing of the segmental block retaining walls present at the front of the development.

View of concrete segmental block masonry  
retaining walls as seen at north end of building –  
several displaced masonry units noted

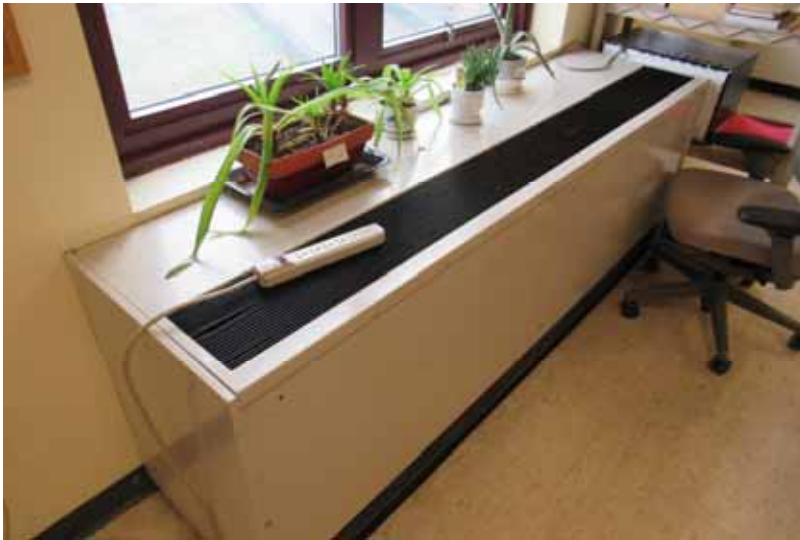
24. Each classroom is equipped with a pneumatically-controlled ventilator that is equipped with a wet heat loop from the boiler plant. Management reports several of the ventilator dampers are problematic at the present time; the ventilators date to the 1997 rehabilitation. Replacement of the ventilators is shown in Year 1, concurrent with replacement/upgrade of the building's pneumatic control system.

View of typical classroom unit ventilator – several ventilators are reportedly problematic at the present time

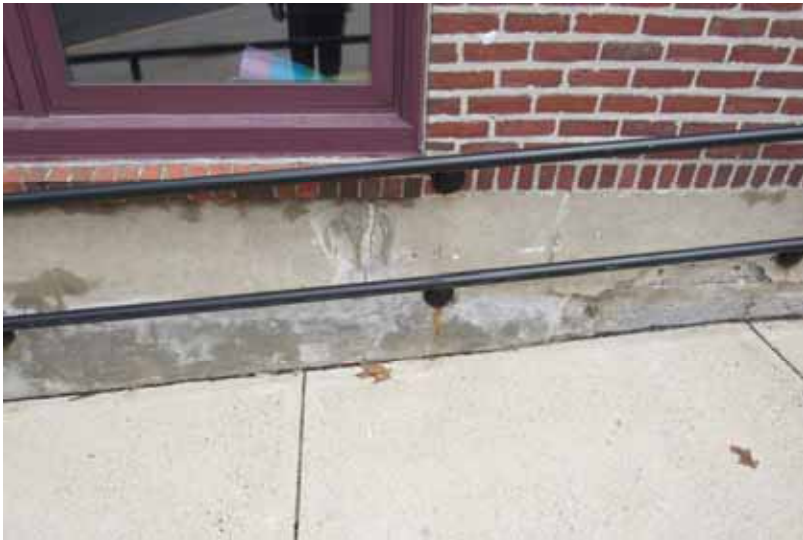
34. Localized cracking and deteriorated cementitious parge coat were observed within the exposed portions of concrete foundation wall. Repairs to the concrete foundation walls are included as part of exterior wall rehabilitation work discussed below. No problems/concerns were reported with regards to the building's main structural framing systems. Isolated areas of apparent efflorescence/moisture staining were observed within the abandoned boiler spaces (i.e., underside of concrete ceilings within basement level) of the building. An allowance for future as-needed concrete repairs and waterproofing efforts are shown in Year 6.

View of cracking within exposed portion of concrete foundation wall – cementitious parge coat exhibits delaminations/wear

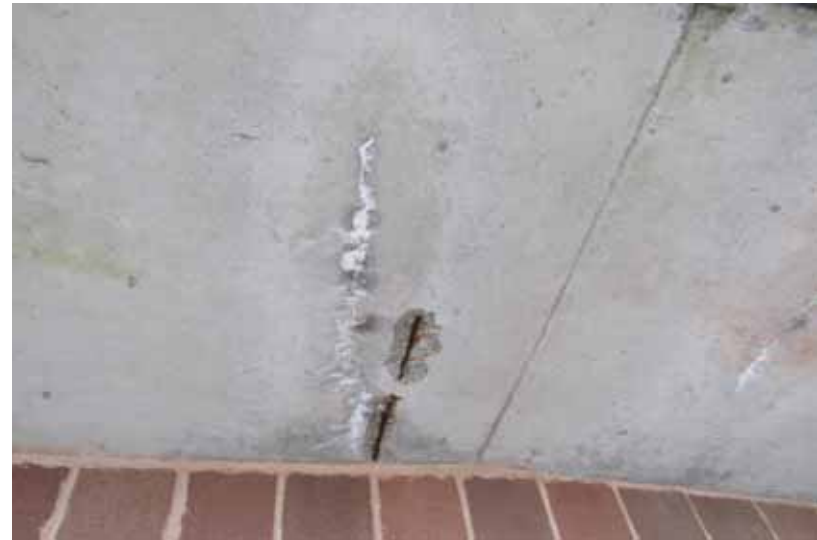
35. An elevated concrete walkway is present at the cafeteria emergency egress. Exposed and corroded reinforcing steel as well as concrete spalls were observed on the underside of the walkway. Costs to carry out concrete repairs as well as addressing corroded reinforcing steel are shown in Year 1.

View of concrete spalls and exposed/corroded reinforcing steel as seen at underside of elevated concrete walkway present towards northwest corner of building

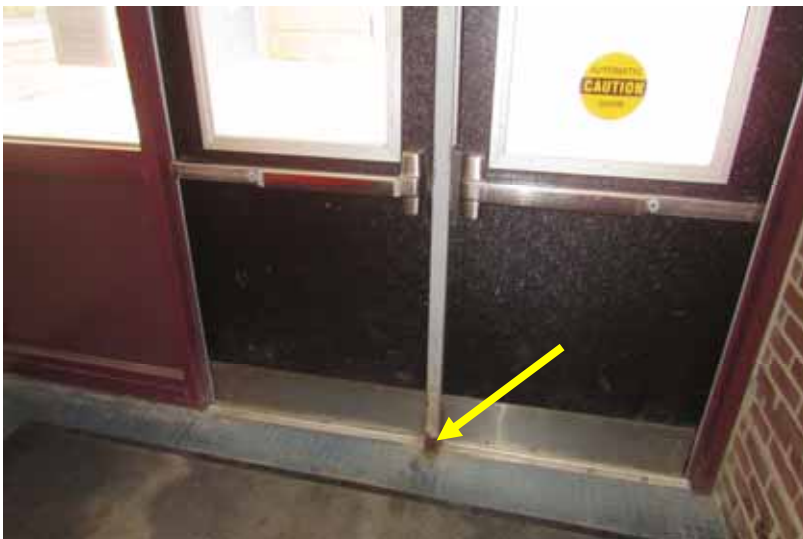
View of main entry doorway framing exhibiting corrosion/wear

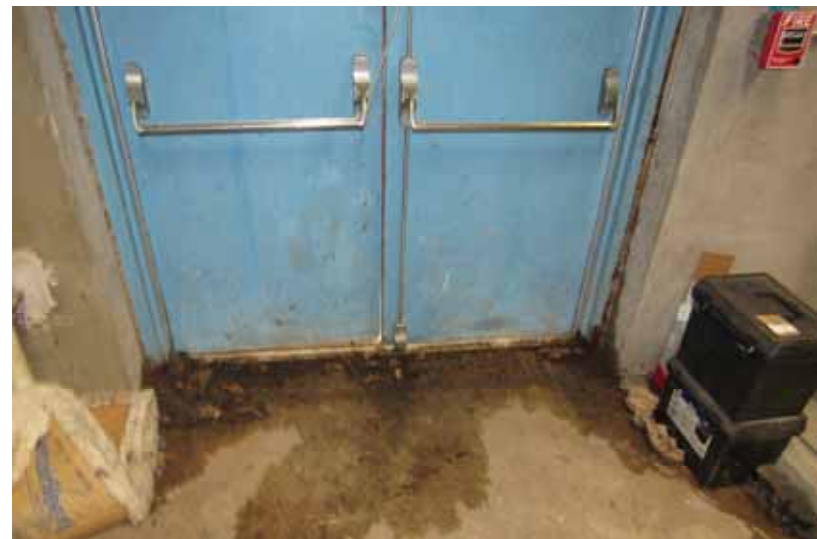
View of double leaf hollow metal service doors exhibiting age related wear/weathering

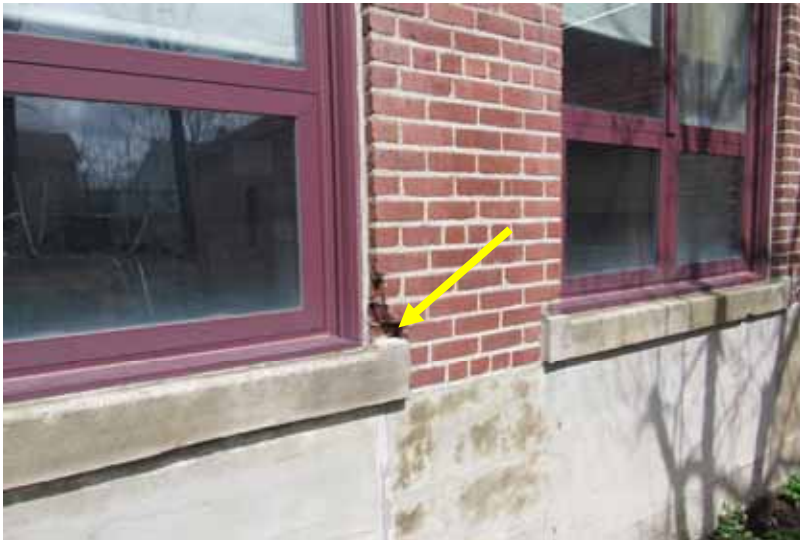
37. Several areas of mortar loss, cracking, spalls/deterioration, exposed and corroded reinforcing steel were observed within the brick and stone cladding, particularly at the north facing elevation of the original building (i.e., exterior walls over roof level). Furthermore, several steel lintels present above window openings exhibit corrosion and deformation. Costs to carry out repairs in the form of repointing, crack repairs, localized brick and stone replacement, and repairs to deteriorated lintel are shown in Year 1. However, it is recommended that these areas of deteriorated be further reviewed by a building envelope professional to determine the full scope and costs of required repair/replacement work.

View of localized deteriorated brick masonry units at window corner

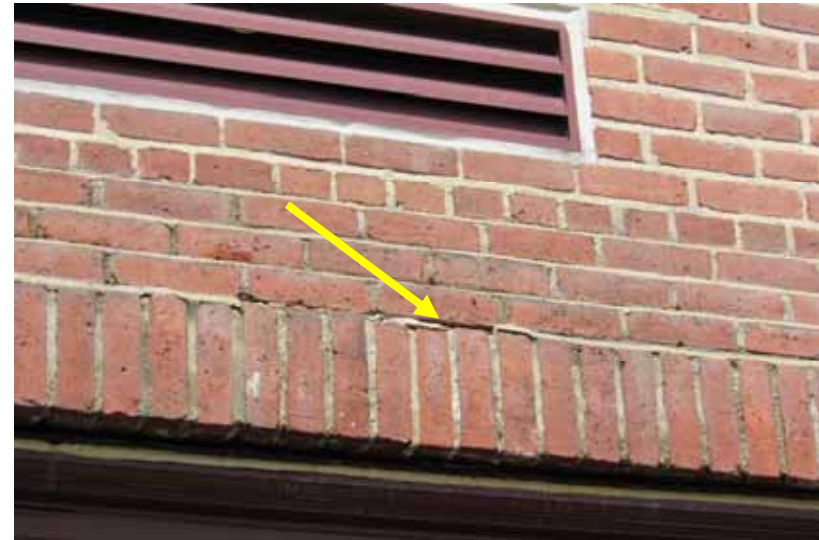
View of localized mortar loss within brick masonry cladding

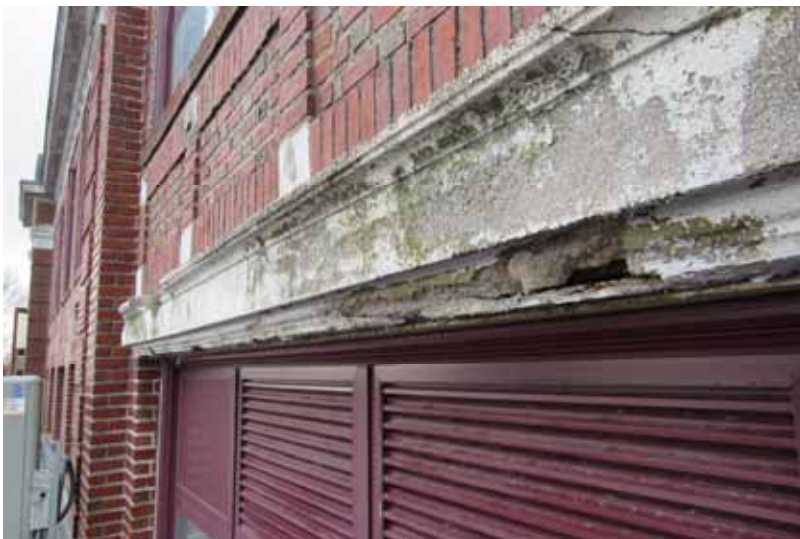
View of pronounced stone cladding deterioration as seen at north facing elevation of original building—also note exposed and corroded reinforcing steel

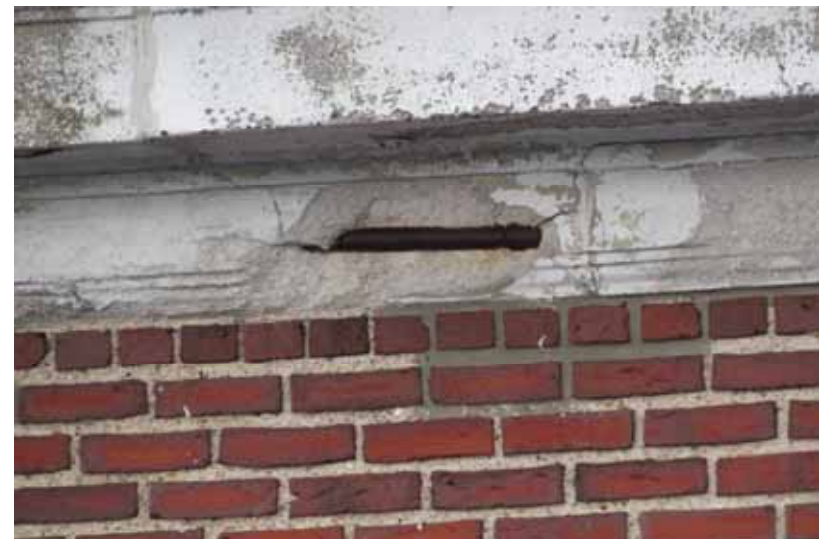
Additional view of corroded/deteriorated reinforcing steel within stone cladding

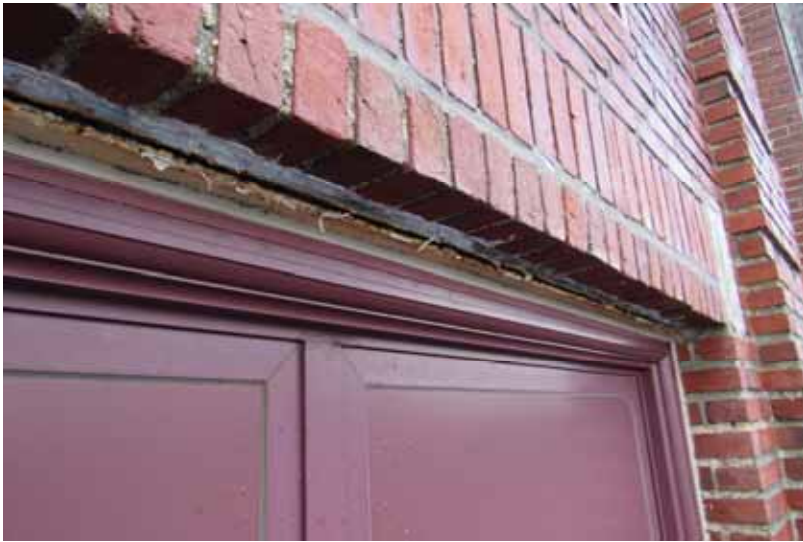
View of steel lintel exhibiting corrosion/deterioration as seen at north elevation of original building

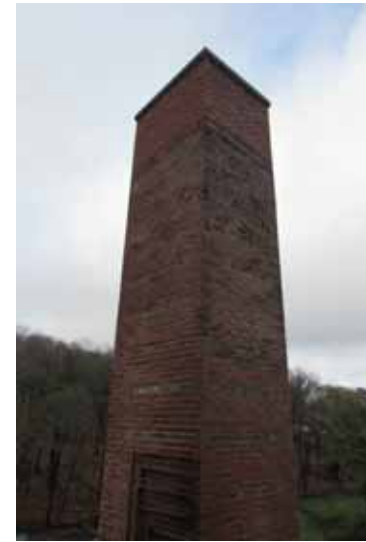
View of brick masonry chimney – widespread mortar loss/deterioration noted

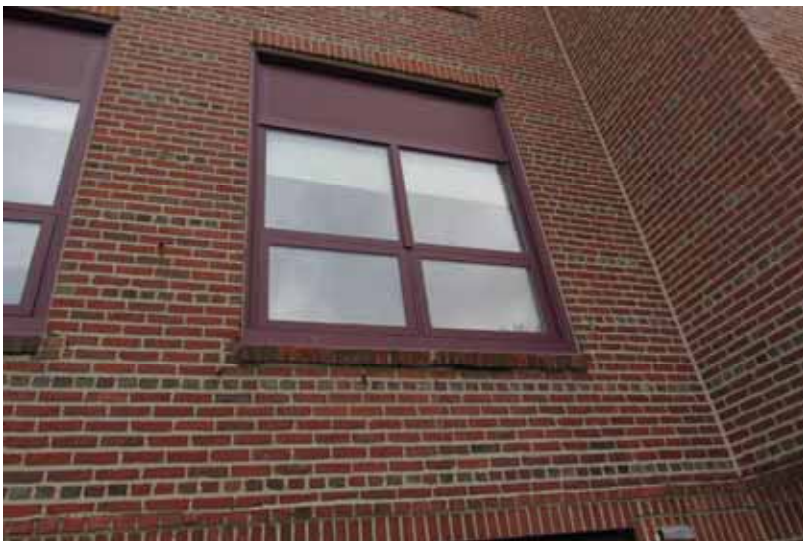
39. The exterior windows reportedly date to the 1997 rehabilitation and are reportedly in good operating condition at the present time. Isolated failed insulating glass units (IGU's) were noted during the site review and costs for localized replacement are shown in Years 1-15 (failure of an IGU is ultimately apparent when condensation forms between the glass panes). Future replacement of the exterior windows is shown in Year 16.

Exterior windows are prefinished aluminum-framed fixed and operable models containing insulating glass units (IGU's) – limited failed IGU's noted during assessment

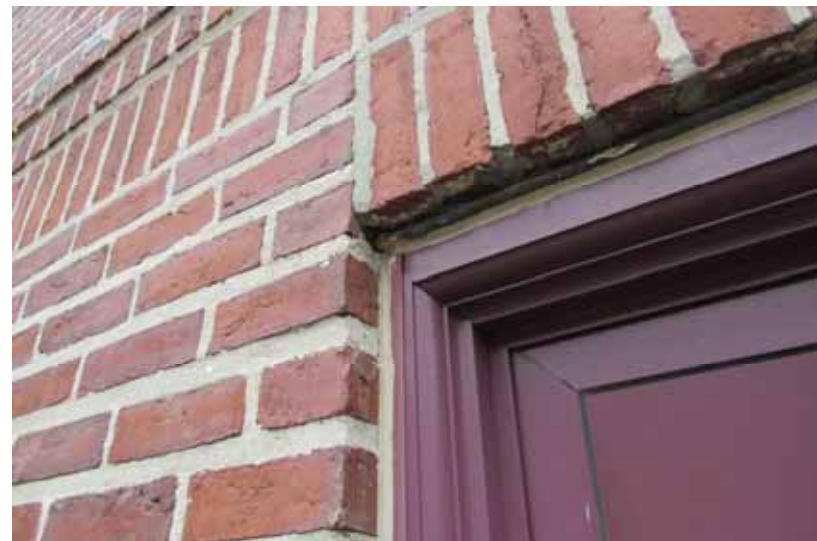
38. Cohesive/adhesive failures were observed within the exterior caulking. Replacement costs are shown in Years 1 and 16, based on a fifteen-year expected useful service life.

View of deteriorated caulking (i.e., cohesive failures) as seen at window perimeter

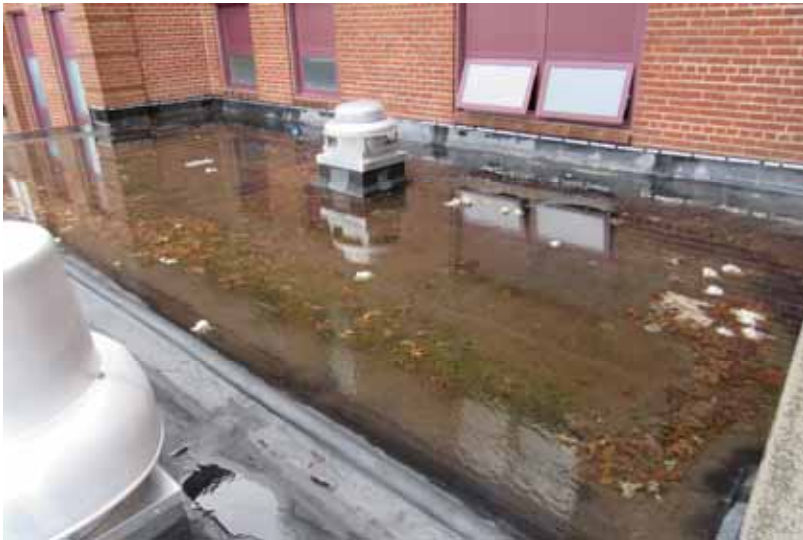
41. Based on discussions with management, areas of active roof leakage are occurring through the EPDM roof assemblies. Several areas of pronounced water ponding were also noted during the site review. Furthermore, localized deteriorated

- seams as well as soft spots (i.e., potentially saturated insulation) were noted during the site review. Based on roof surface serial numbers, the majority of the EPDM roof assemblies date to the 1997 rehabilitation. Replacement of the EPDM roof assemblies is shown in Year 1, based on the roofs exceeding a normal expected useful service life of twenty-years.

Several areas of water ponding observed on EPDM roof surfaces

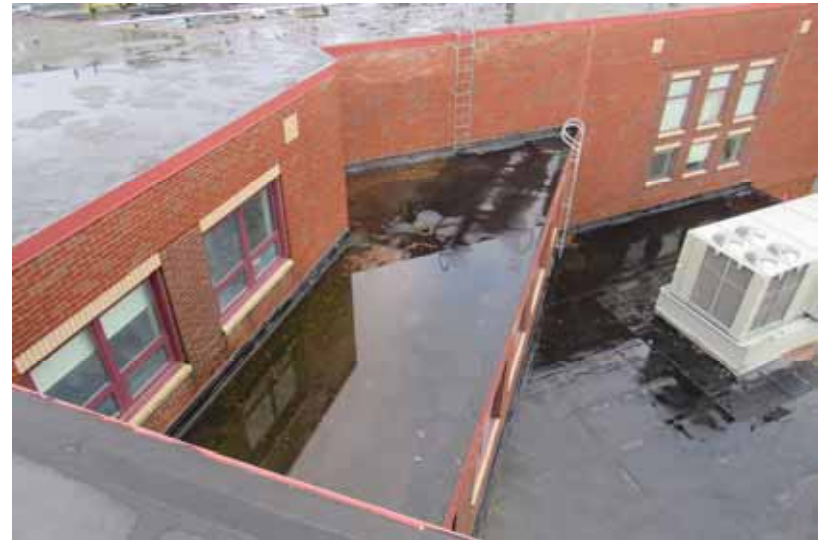
Additional view of water ponding on roof surfaces as seen at lower roof area

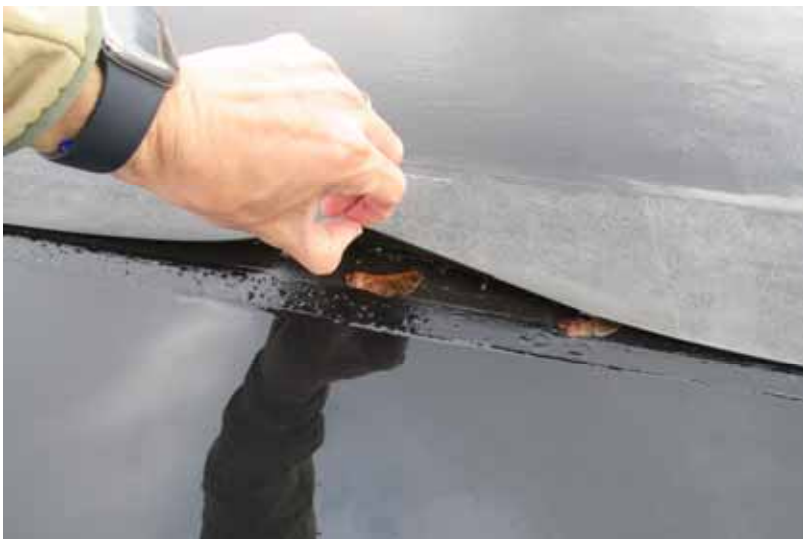
View of poorly adhered section of roof membrane

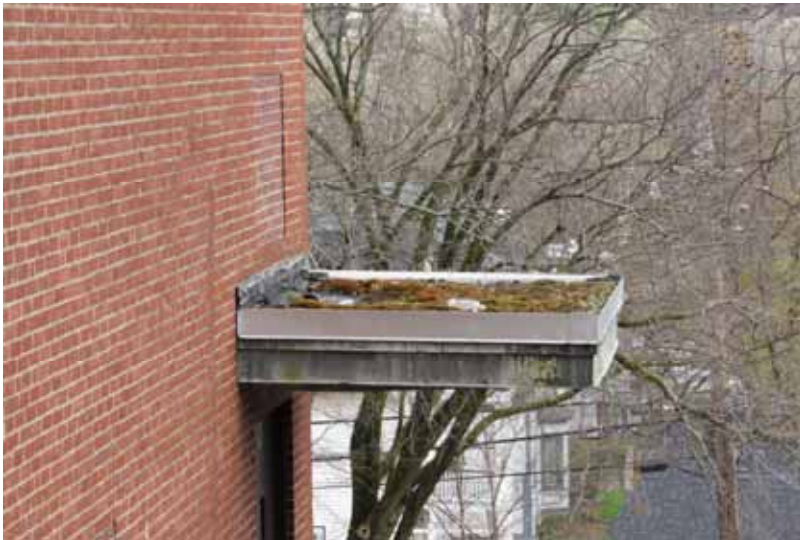
42. Pronounced vegetation growth and evidence of poor drainage was noted at select canopies (i.e., northeast corner of building). Costs to replace these roof sections are included with the aforementioned EPDM roof assembly replacement work.

View of widespread vegetation growth and evidence of poor drainage as seen at canopy roof located towards northeast corner of building

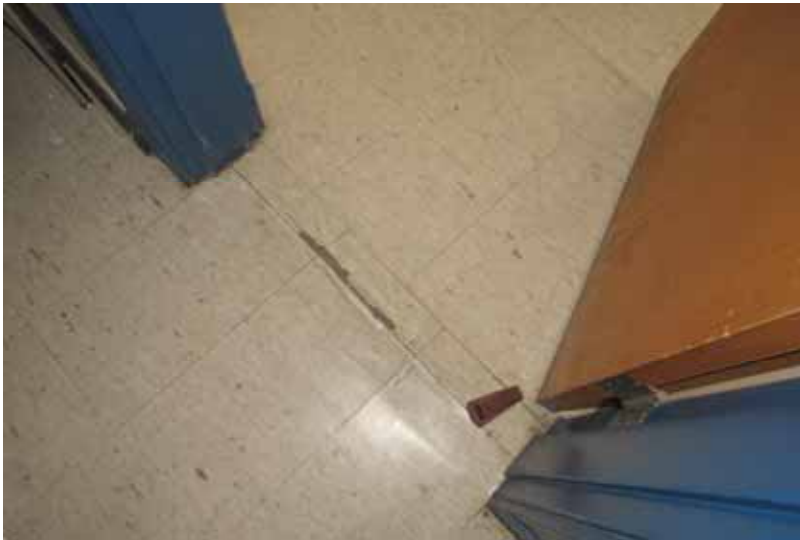
Localized cracking/deterioration noted within VCT flooring

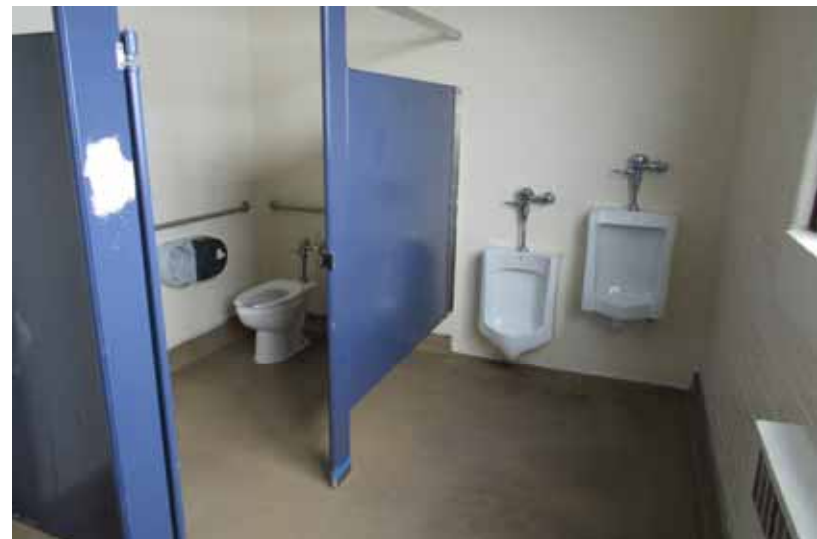
View of typical common restroom finishes and fixtures – age related wear

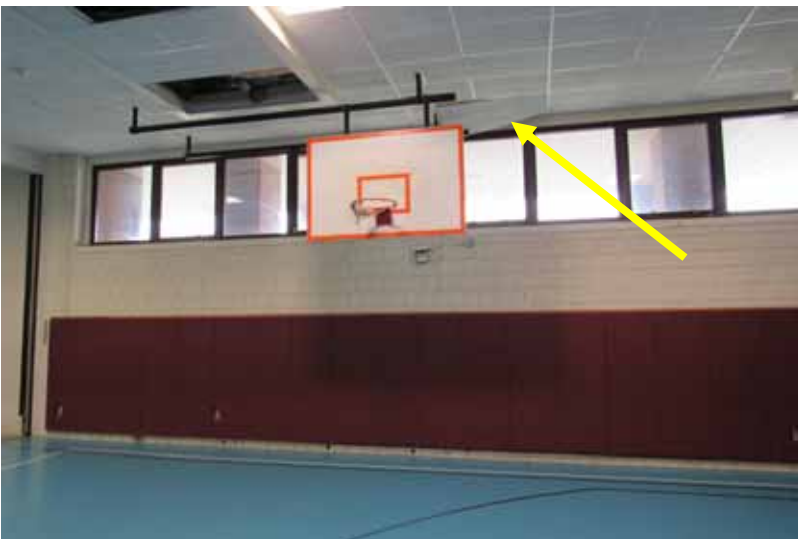
View of blue gym finishes – note rubberized flooring – also note displaced suspended ceiling tiles and potential overhead risk

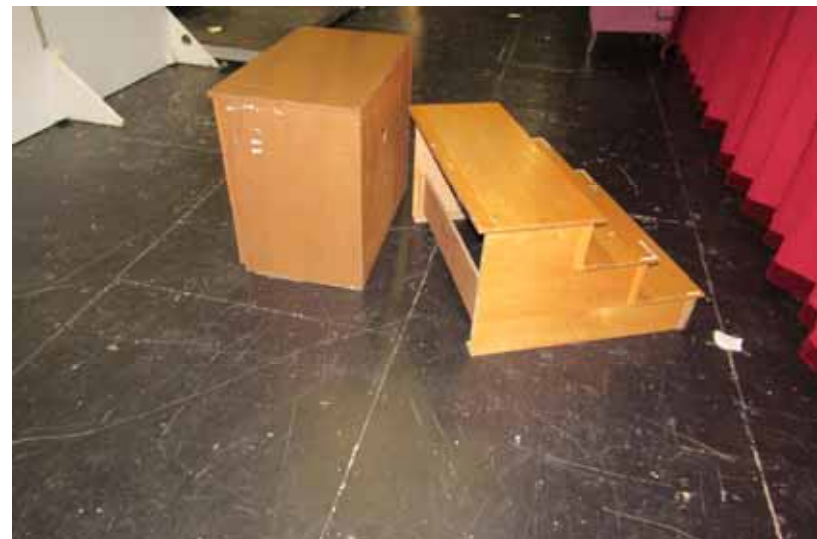
View of main gym stage flooring exhibiting age related wear

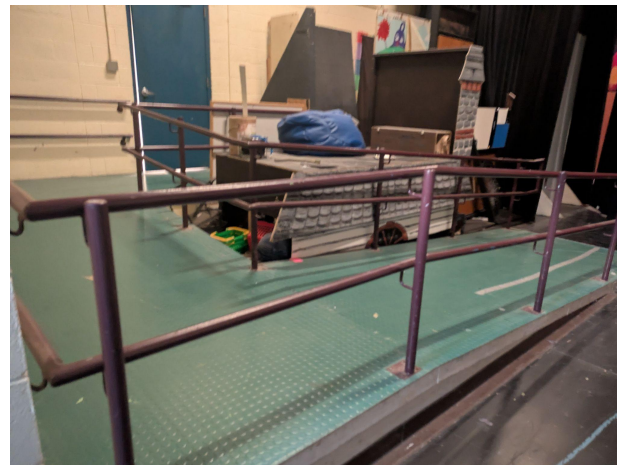
*Cumbersome and difficult-to-find ramp to Wood Gym does not include lighting at the top of the ramp.*

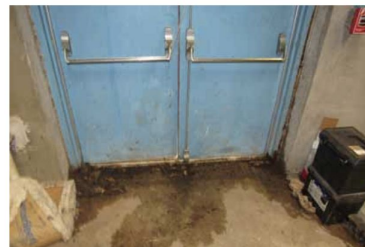
View of double leaf hollow metal service doors exhibiting age related wear/weathering

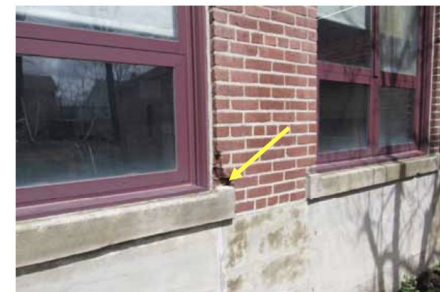
View of localized deteriorated brick masonry units at window corner

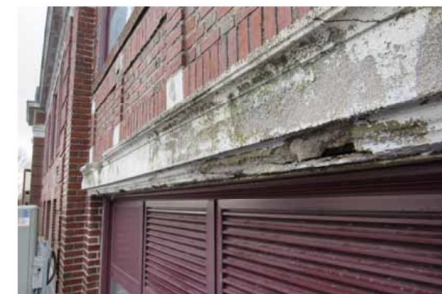
View of pronounced stone cladding deterioration as seen at north facing elevation of original building—also note exposed and corroded reinforcing steel
